APPENDIX C

Photograph Log and Photographs

PHOTO LOG

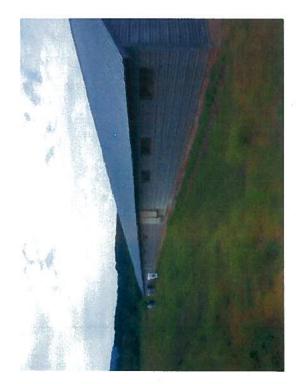
Photo Reference	Photo Filename ¹	Coordinates Where Photo Taken	Description
Photo 1	2011-06-1609.45.28.JPG		GPS unit showing time of 9:33:24 AM.
Photo 2	2011-06-1609.45.37.JPG		(Integrator)
Photo 3	2011-06-1610.33.29.JPG		Chicken House No. 4, front View
Photo 4	2011-06-1610.34.07.JPG		Chicken House No. 4, East View
Photo 5	2011-06-1610.36.26.JPG		Drainage from Co. Rt. 7, leading to culvert that goes under House No. 4. Drainage is flowing west towards South Fork River.
Photo 6	2011-06-1610.39.03.JPG		Sidewall ventilation, east side of House No. 4
Photo 7	2011-06-1610.40.04.JPG		Hose to flush drinking water system. House No. 4, east side.
Photo 8	2011-06-1610.41.04.JPG		South side entrance of House No. 4.
Photo 9	2011-06-1610.42.34.JPG		Culvert influent
Photo 10	2011-06-1610.43.08.JPG		Ditch line on east side of House No. 4, discharges through this culvert at farm access road, west of House No. 4.
Photo 11	2011-06-1610.45.36.JPG		Discharge from culvert that flows under House No. 4 (see Photo 5). Flows into pond.

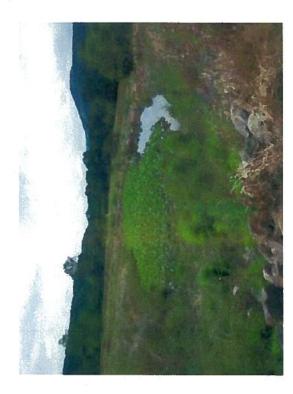
Photo 12	2011-06-1610.46.49.JPG		Overall view of pond located west of No. 4 and south of No. 3.
Photo 13	2011-06-1610.47.36.JPG		Runoff ditch to pond between No. 4 and No. 3.
Photo 14	2011-06-1610.48.11.JPG		Access road between No. 4 and No. 3. Drains to pond.
Photo 15	2011-06-1610.49.17.JPG		South side entrance to House No. 3.
Photo 16	2011-06-1610.50.17.JPG		Drainage between House No. 3 and No. 2.
Photo 17	2011-06-1610.50.47.JPG		Outlet via culvert from drainage between House No. 3 and No. 2.
Photo 18	2011-06-1610.51.56.JPG		Compost shed located southeast of House No. 2.
Photo 19	2011-06-1610.52.25.JPG		Overall view of compost shed looking south.

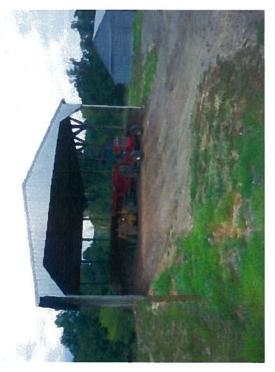
Photo Reference	Photo Filename ¹	Coordinates Where Photo Taken	Description
Photo 20	2011-06-1610.53.23.JPG		Dry manure storage shed facing west.
Photo 21	2011-06-1610.54.10.ЈРС		Drainage slanted south in front of dry manure storage shed.
Photo 22	2011-06-1610.55.32.ЈРС		South entrance of House No. 2.
Photo 23	2011-06-1610.56.32.ЈРС		Drainage area between House No. 2 and House No. 1 facing north.
Photo 24	2011-06-1610.57.35.JPG		South side of House No. 1.
Photo 25	2011-06-1610.59.59.JPG		Drainage of north side of dry manure storage shed (See photo 19).
Photo 26	2011-06-1611.02.49.JPG		Drainage on west side of House No. 1.
Photo 27	2011-06-1611.12.30.JPG		Discharge leading north from House No. 1.
Photo 28	2011-06-1611.13.04.JPG		North entrance of House No. 1.
Photo 29	2011-06-1611.14.03.JPG		Drainage off property from House No. 1.
Photo 30	2011-06-1611.16.30.JPG		North entrance of House No. 2.
Photo 31	2011-06-1611.19.51.JPG		Above view of discharge from pond.

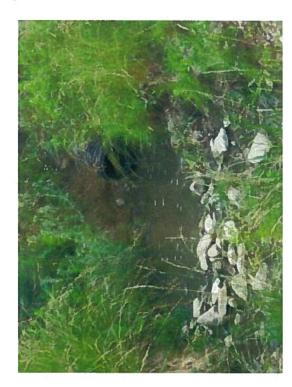
Photo 32	2011-06-1611.22.12.JPG		View of point source discharge, facing east of pond
Photo 33	2011-06-1611.25.16.JPG		Discharge point from channel below pond into South Fork.
Photo 34	2011-06-1611.28.26.JPG		Upstream view of South Fork River from bridge.
Photo 35	2011-06-1611.28.45.ЈРС		Downstream view of South Fork River from bridge.
Photo 36	2011-06-1611.29.27.JPG		From bridge, view of discharge channel into South Fork River
